May 2, 2012

NOTICE TO ALL SAFARI OWNERS REGARDING INSPECTION OF FLEX COUPLING

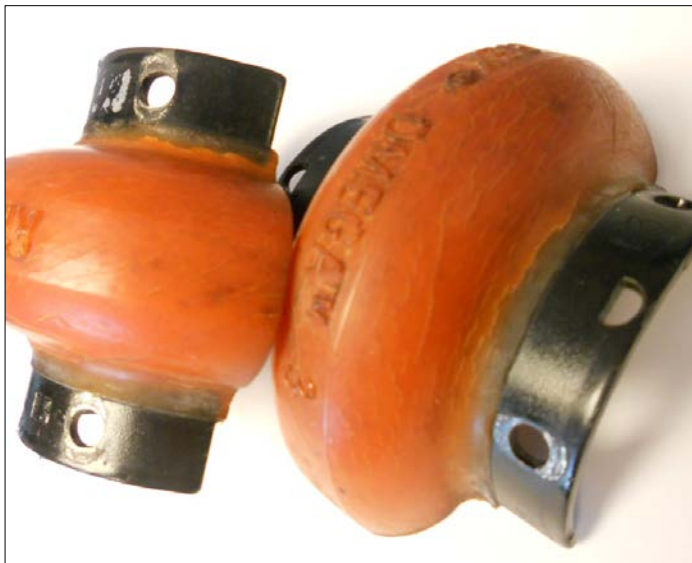
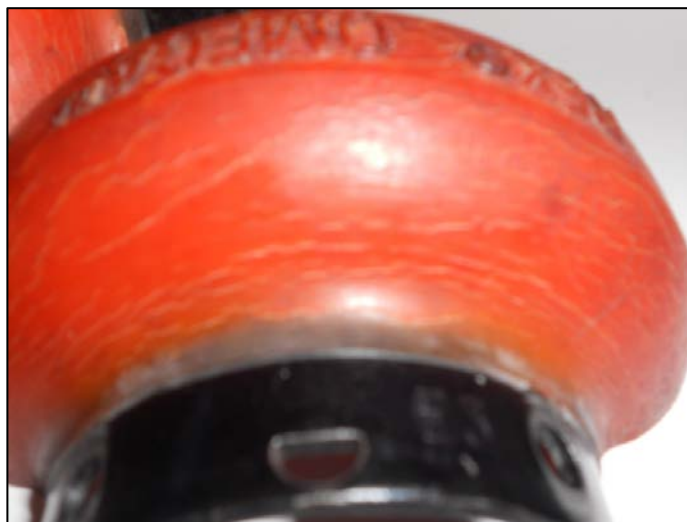
As the photos below illustrate, the Flex Coupling used to connect the main transmission to the tail rotor drive shaft can deteriorate with time and exposure. Inspection of this part should be included in the 100 hour inspections performed on your aircraft. This is an easy and inexpensive part to replace, and it should be replaced when there is visible cracking of the type illustrated in the photos. Please contact the factory with any questions or concerns.
