MI-003 Horizontal Stabilizer Mandatory Inspection and Modification

April 6, 2015

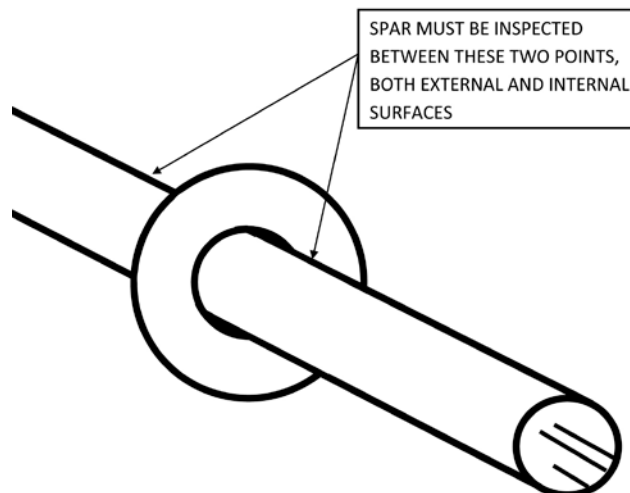
Area to be inspected:

We have observed evidence of fatigue cracking at the location of a horizontal stabilizer positioning flange, which has the potential to break in flight.

In manufacturing the center tube of the horizontal stabilizer, a circular flange of 4130 Chromoly steel is slid onto the tube and welded in place. This is matched to a slightly larger piece of tubing and flange which is welded to the tail boom.

It is necessary to remove the horizontal stabilizer and inspect the interior and exterior of the tube at the location of the circular flange. Unless the sheet metal that forms the horizontal stabilizer wing is attached at adequate distance from the flange to allow inspection, the sheet metal skin must be removed to inspect the flange on the outboard side.

Area of concern should be inspected using Liquid Penetrant Inspection. A great deal of information about conducting this type of inspection is available including this excerpt from the FAA handbook "Inspection Fundamentals":

If no evidence of fatigue cracking is found, an 8 inch insert of 7/8" x .058" 4130 Chromoly steel tubing must be installed into the end of the stabilizer to extend the full length of the tail boom mount. This insert should extend between the second and third rivet that secures the sheet metal of the stabilizer to the center tube and must be welded to the center tube at the end of the spar. Rivets which are removed to allow installation of the insert should be replaced with Cherry Max or AN470AD-4-5 hard rivets. The sheet metal should be modified if necessary for it to be positioned far enough away from the welded flange to allow future inspections without disassembling the stabilizer.

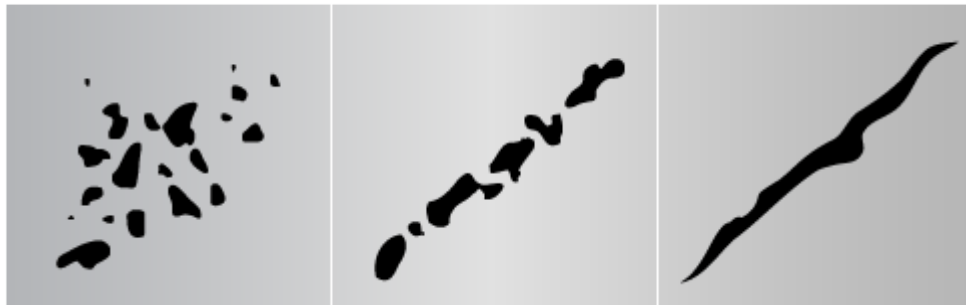
Figure 8-4. Types of defects

The size of the indication, or accumulation of penetrant, will show the extent of the defect and the brilliance will be a measure of its depth. Deep cracks will hold more penetrant and will be broader and more brilliant. Very fine openings can hold only small amounts of penetrants and will appear as fine lines. Figure 8-4 shows some of the types of defects that can be located using dry penetrant.

Pits of porosity

Tight crack or partially welded lap

Crack or similar opening
